Memorandum

October 9, 2002

SUBJECT: SR-104, OL 3305
Hood Canal Bridge Replacement
Geotechnical Recommendations for Anchor Design

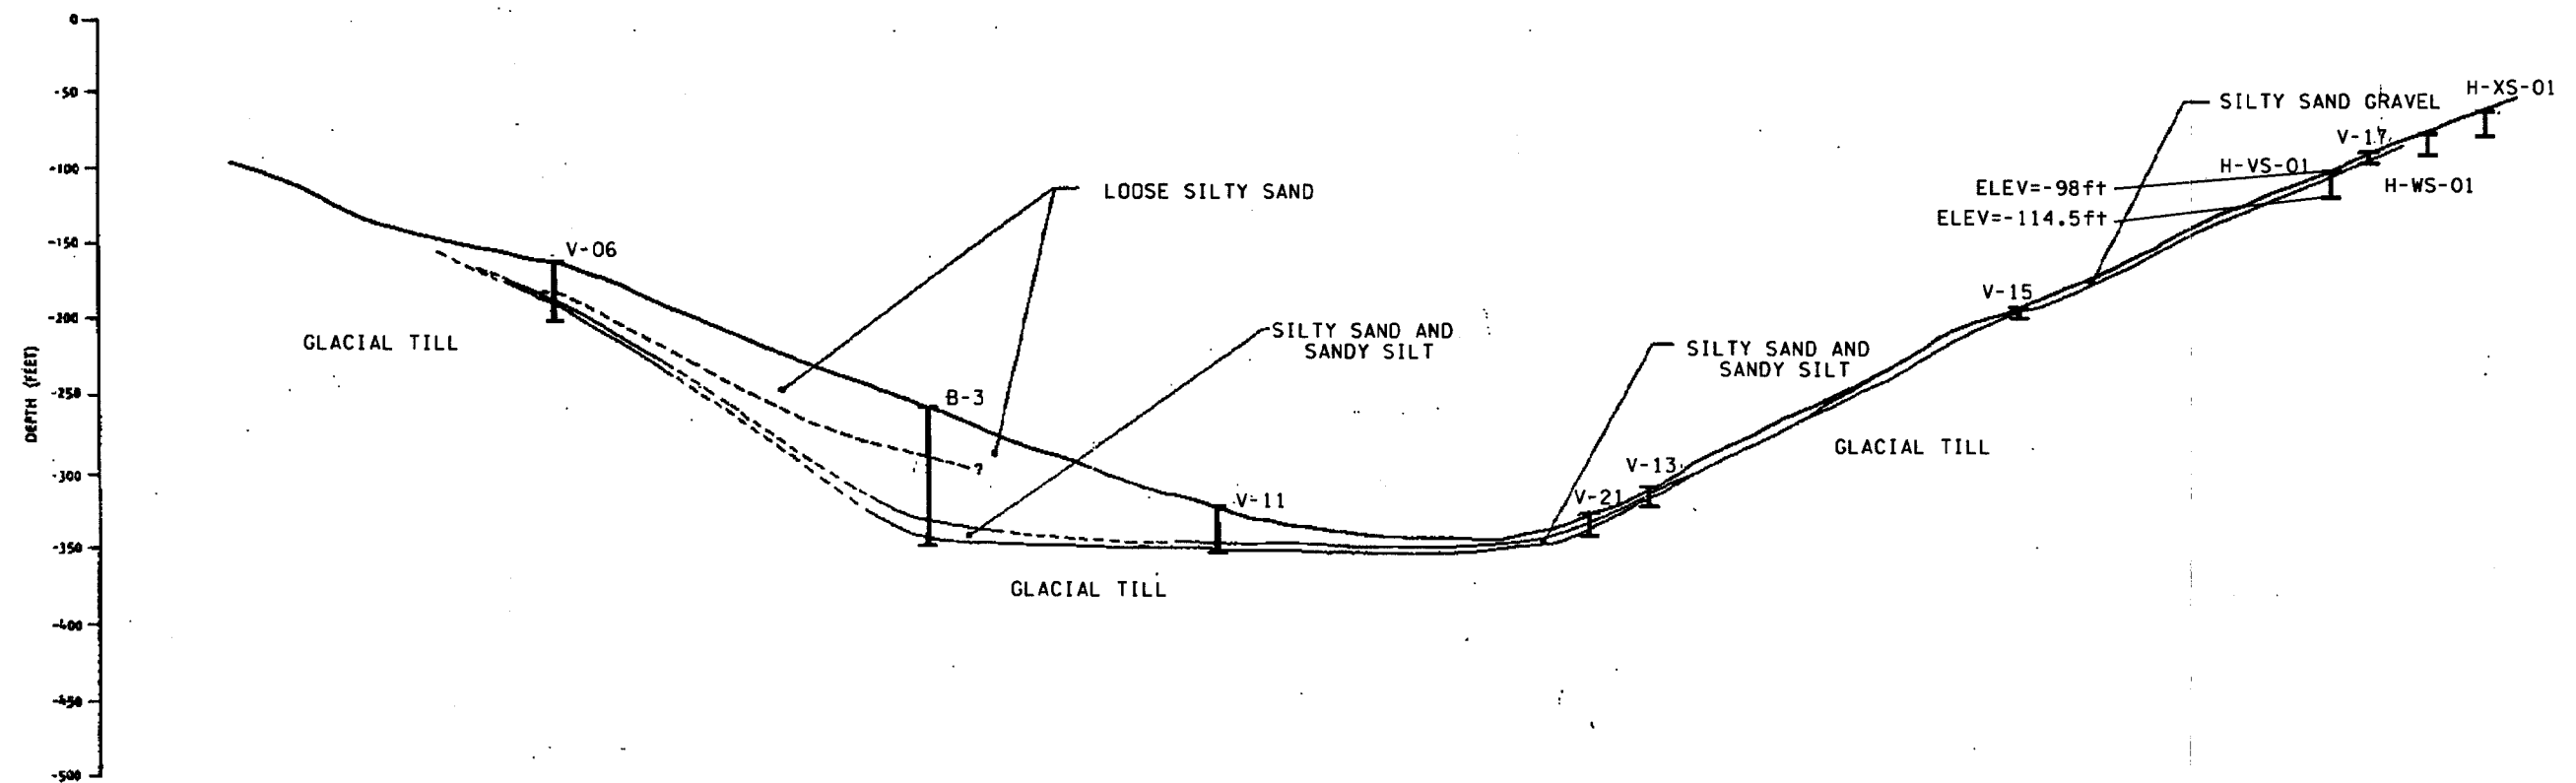
FIGURE 4: SOUTH ANCHOR LINE SUBSURFACE PROFILE

- I B-1 BORING PERFORMED IN 1980
- I V-17 VIBRACORE PERFORMED IN 1980
- I H-VS-01 BORING PERFORMED IN 2001

The principal purposes of the current exploration program were to verify and supplement the subsurface data obtained in the previous investigations. Along the south line of the proposed anchors, Vibracore V-17 was made in the vicinity of H-XS-01 and H-WS-01. The subsurface conditions observed in the vibracore indicated approximately 4 feet of medium dense sandy gravel overlying dense silty sand (glacial till). The subsurface conditions observed in H-XS-01 and H-WS-01 both indicate very dense sand with gravel (glacial till) beginning at or near the mud line. Therefore, this data appears to confirm the previous data. H-VS-01, which was made further downslope, encountered 10 feet of loose gravel with sand overlying very dense gravel with sand (glacial till). Vibracore V-15, made even further downslope, suffered an equipment malfunction that prevented the collection of density data. However, the thickness of loose material at that location was interpreted to be shallow, on the order of 2 feet or so. Based upon the data obtained in H-VS-01, it appears that the depth to dense material (glacial till) may be slightly larger than described in the previous reports.

Subbottom profiles in the vicinity of the north and south lines of proposed anchors on the western portion of the bridge are shown in Figures 4 and 5. Each profile presents an assessment of the subbottom conditions developed from all of the information obtained in the current and previous field explorations.

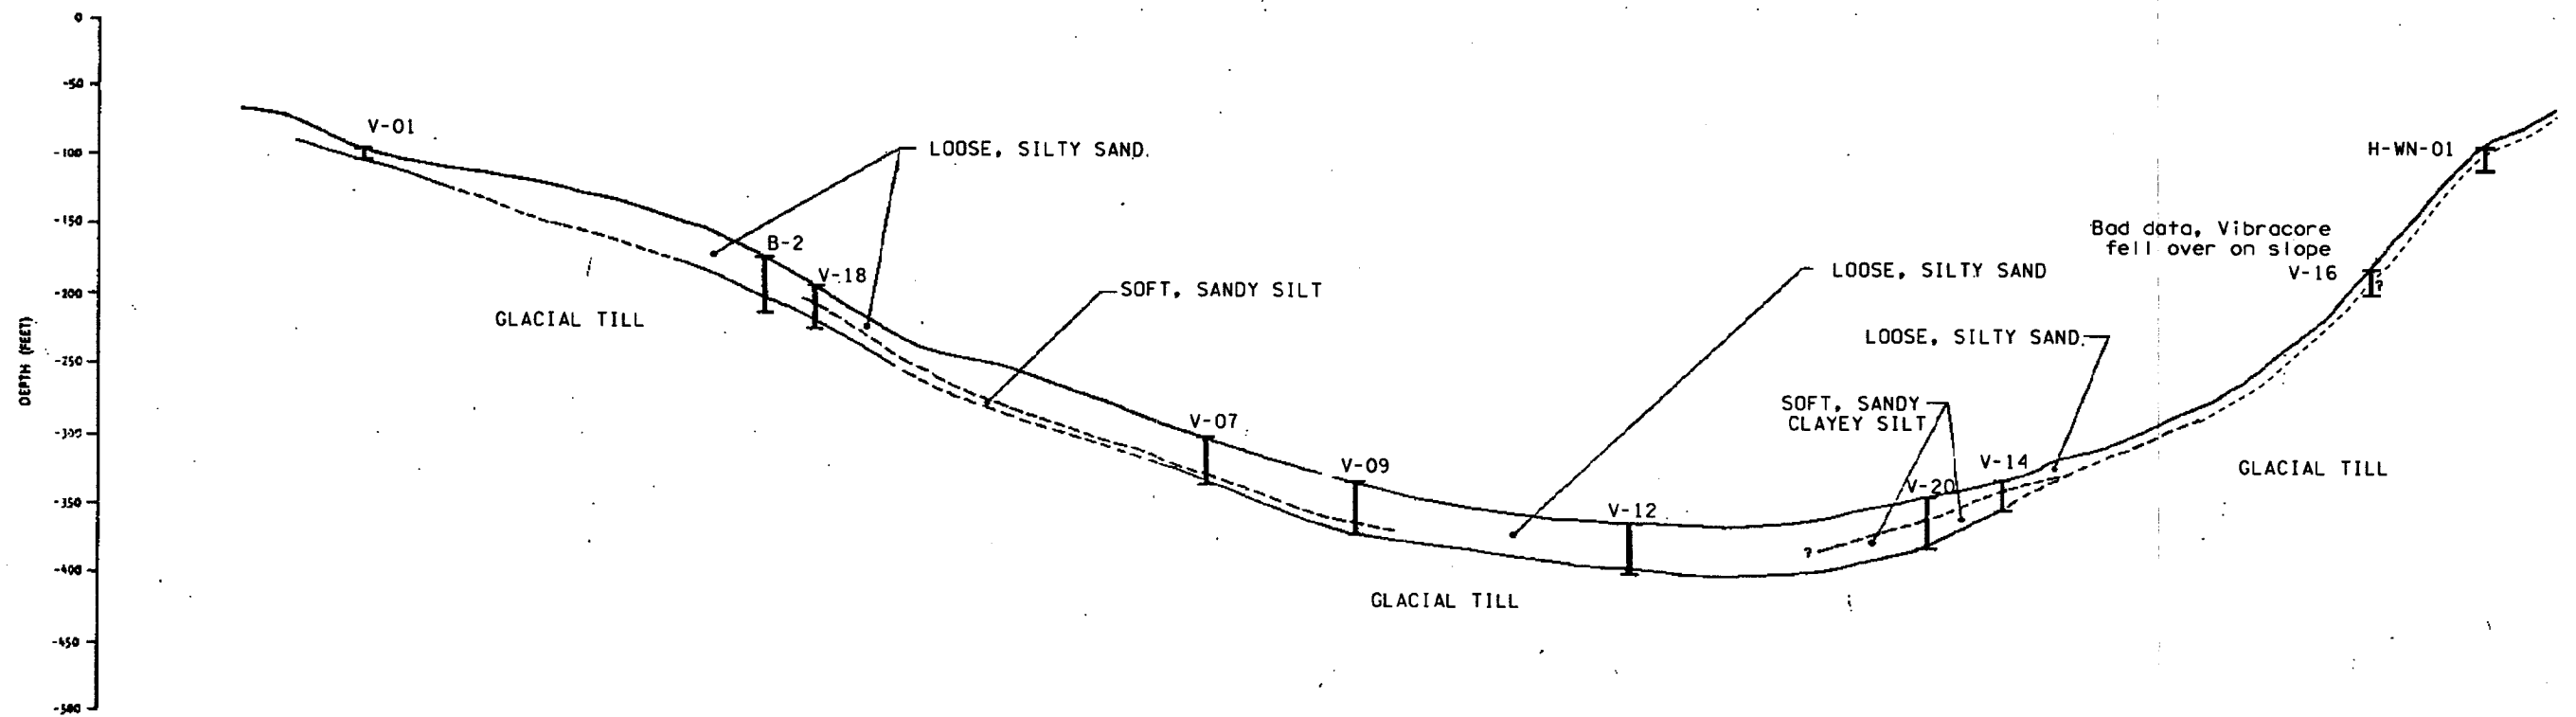
FIGURE 5: NORTH ANCHOR LINE SUBSURFACE PROFILE

- I B-2 BORING PERFORMED IN 1980
- I V-12 VIBRACORE PERFORMED IN 1980
- I H-WN-01 BORING PERFORMED IN 2001

Along the north line of the proposed anchors, Vibracore V-16 was made in the vicinity of H-WN-01. The subsurface conditions observed in the vibracore indicated approximately 3 feet of loose sand with gravel and shell fragments overlying loose silty sand extending to the full depth of the vibracore sample at 18 feet. No dense material (glacial till) was observed in the vibracore. The subsurface conditions observed in H-WN-01 indicate 5 feet of loose gravel with sand overlying dense gravel (glacial till). This apparent discrepancy can be explained by a note on the vibracore log that states "Vibracore fell over on steep slope at indicated penetration depth of 18 feet. Penetration depth may be in error. All soil collected may be near the surface". Based upon the results of the current investigation, it appears that this statement is correct and the proper depth to dense material (glacial till) in this portion of the site is approximately 5 feet.

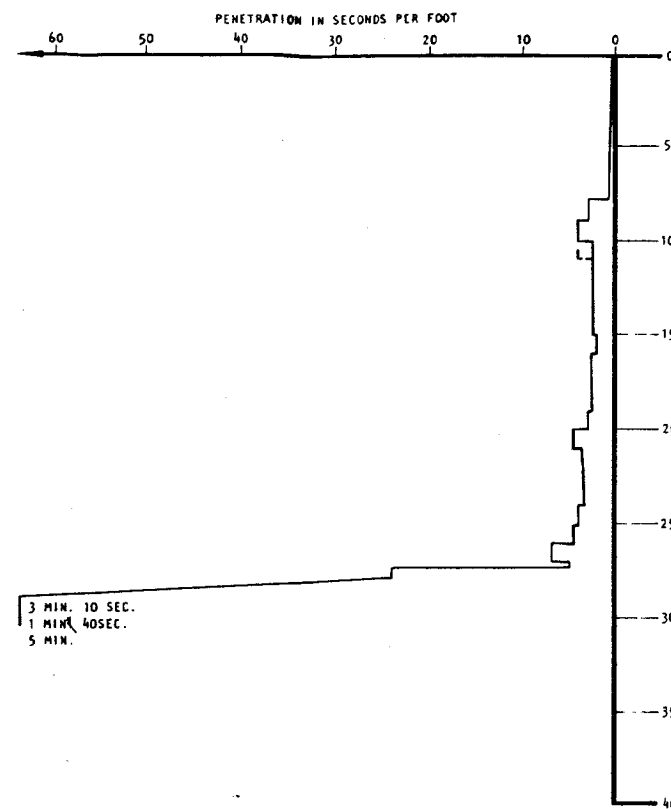
VIBRACORE 18

SM SILTY FINE SAND WITH SHELL FRAGMENTS (VERY LOOSE TO LOOSE).
ML FINE SANDY SILT WITH TRACE OF SHELL FRAGMENTS (SOFT).
SM SILTY MEDIUM-COARSE SAND WITH SHELL FRAGMENTS (MEDIUM DENSE).
GW GRAVEL AND COBBLES.
SM SILTY FINE-COARSE SAND WITH TRACE OF GRAVEL (VERY DENSE).

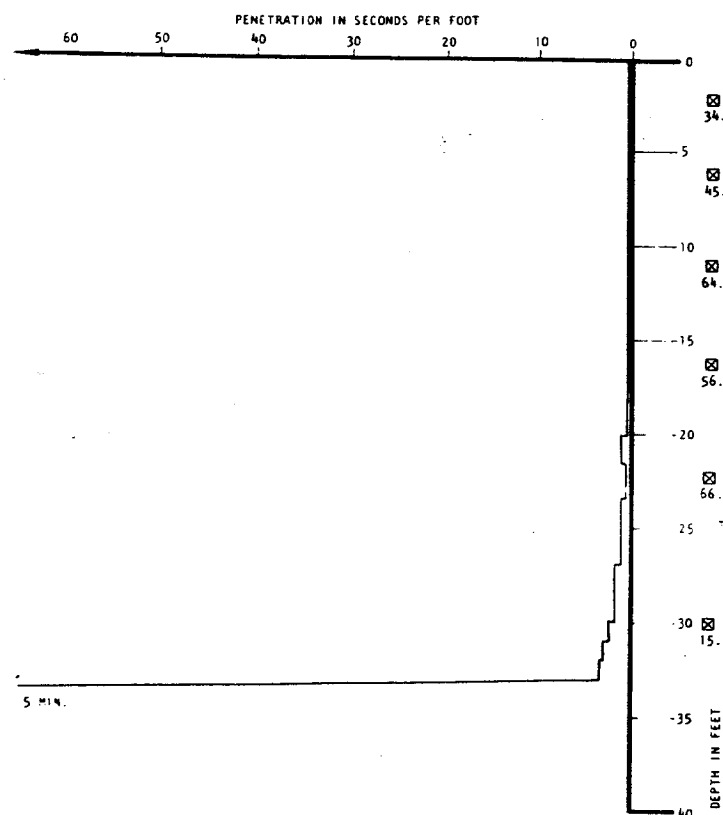
VIBRACORE 19

ML FINE SANDY SILT AND SILTY SAND WITH OCCASIONAL SHELL FRAGMENTS (VERY LOOSE).
SM
SP COARSE SAND (LOOSE).
SW COARSE SAND AND GRAVEL (DENSE).

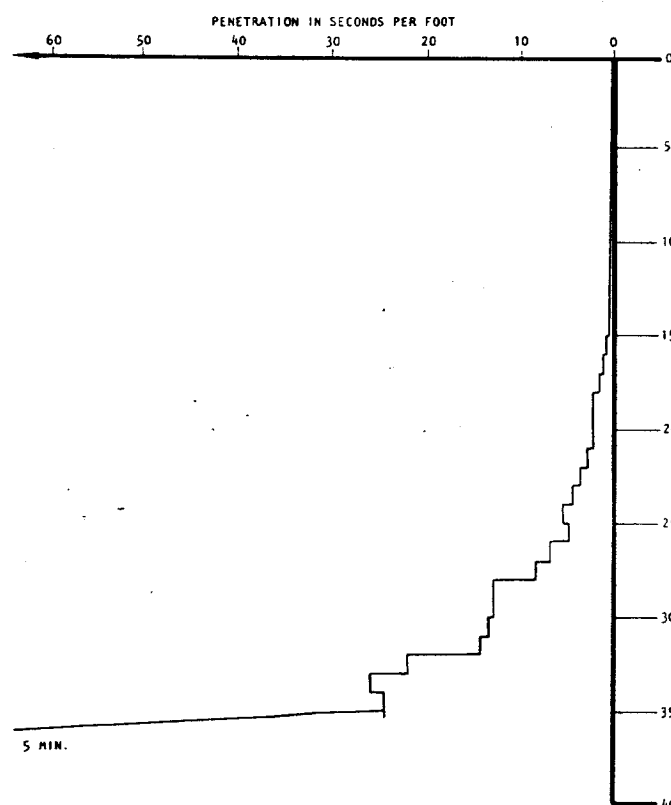
VIBRACORE 20

SM SILTY FINE SAND WITH SHELL FRAGMENTS (VERY LOOSE TO LOOSE).
ML SANDY SLIGHTLY CLAYEY ORGANIC SILT WITH SHELL FRAGMENTS (SOFT).
GRADING LESS ORGANIC.
GRADES MEDIUM STIFF.
GW SAND/ GRAVEL (DENSE).

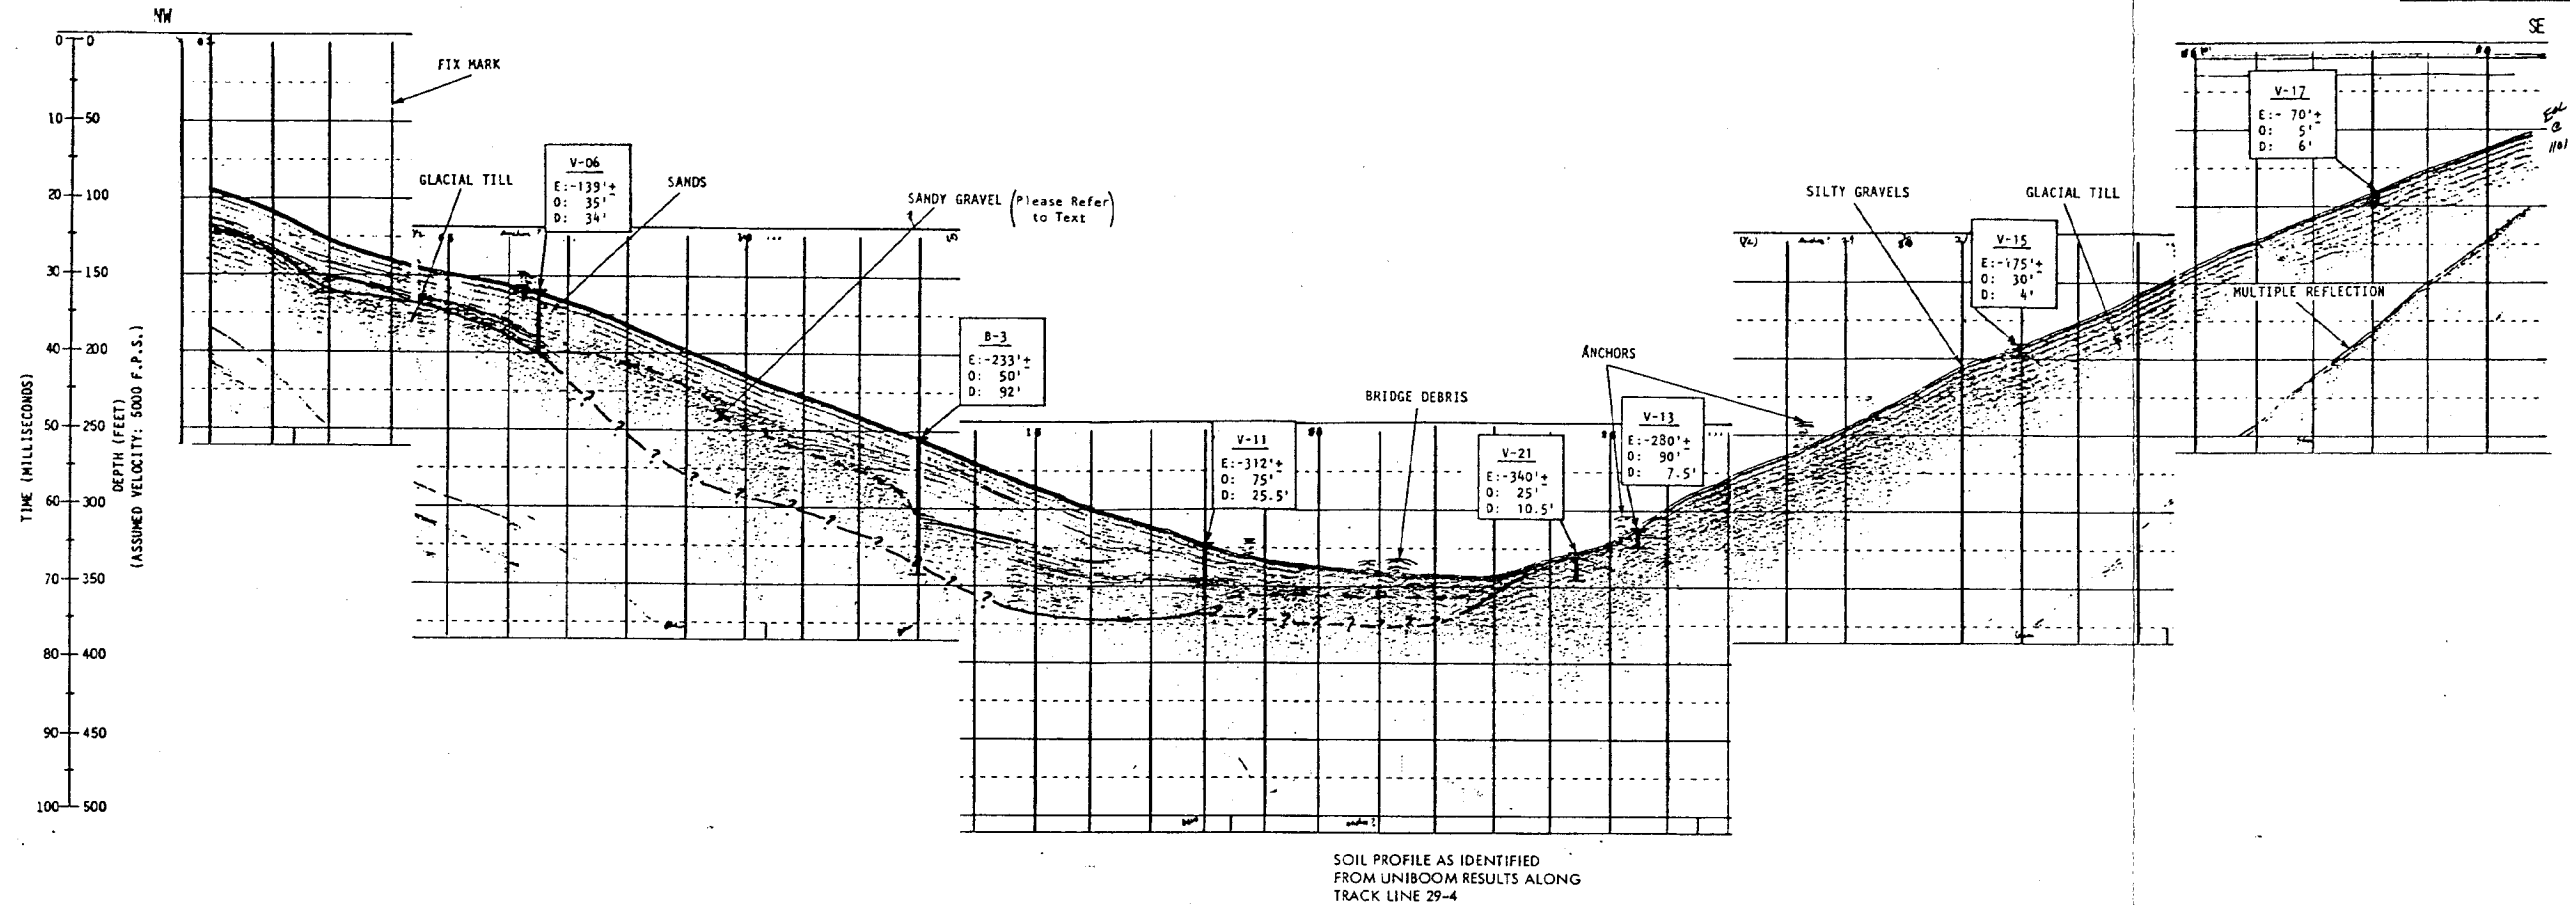
</div>				SR 104 MP 13.96 to MP 14.73 Jefferson and Kitsap Counties				SCALE									
										DRAWN BY JAMES F. BECKER								HOOD CANAL BRIDGE REPLACEMENT				CONTRACT NO.									
										CHECKED BY S. JOHNSTON								PROFILE				DWG NO. - REV.									
										IN CHARGE J. K. TUTTLE								SOUTH SIDE ANCHOR LINE				6 03									
DATE	BY	SUB	APP	DESCRIPTION						REV.	DATE	BY	SUB	APP	DESCRIPTION						DATE					APPROVED	SUBMITTED	APPROVED	SHEET OF SHEETS		
																				13 AUG 80						15 AUG 80

As indicated on the subbottom profiles in Appendix B, the line of the proposed anchors appears to be underlain by loose to medium dense sandy silt or silty sand, loose to medium dense silty sandy gravel, and dense silty gravelly sand (glacial till). The thickness of the looser materials over the till is as great as 85 feet near the midpoint of the channel. Towards the eastern side of the bridge alignment, near the lines of proposed anchors, the thickness of the looser material is much less. Some of the vibracore data indicates looser material thicknesses of 2 feet or less.
